Common problems with laminate flooring installations

This document is intended to help identify problems that commonly occur with Laminate Flooring installations.

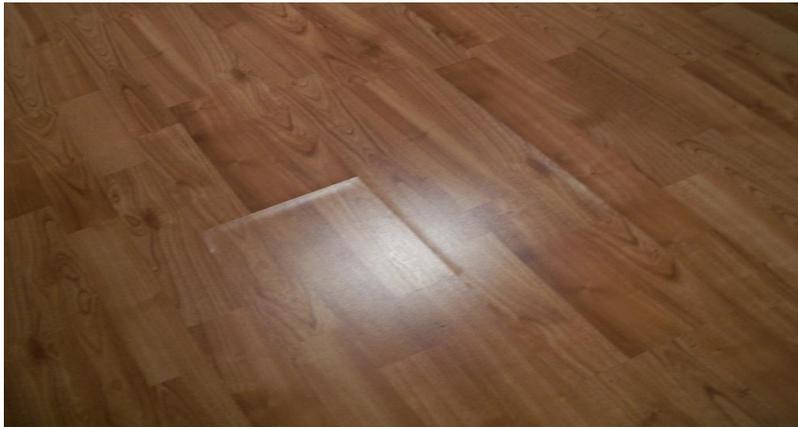
Picture 1

Lack of proper clearances around the walls and fixtures can also cause edge swelling as shown in the picture below.

As a floor expands, if proper expansion joints have not been allowed for or if there is a resulting lack of proper clearances this will cause the opposite effect of board opening as board grow. If there is a lack of clearances and this remains un-checked the effect will be that the edges will compress and look like edge swell (picture 1 above). This will often occur prior to crowning, as dealt with below.

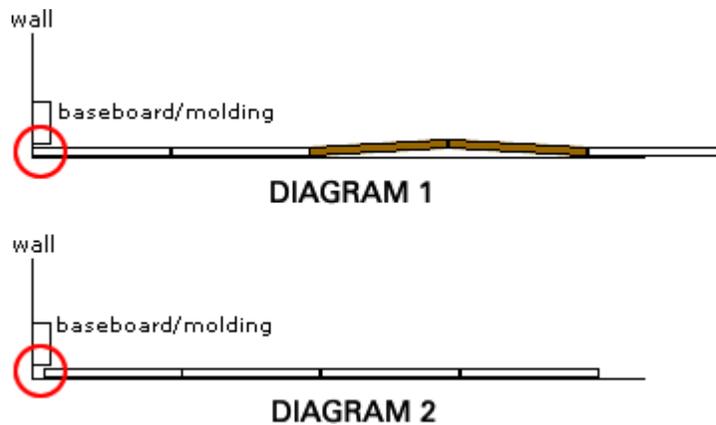
Crowning of floors or peaking is an early indication that the floor is abutting against a wall or at some expansion point where the expansion joint may have become insufficient, see diagram below. (Often doorways, columns and even walls). This can easily be caused by expansion of the boards as the humidity increases over a period of months (please note point 5 above).

It's not uncommon for floors, laid in the low humidity periods, to expand in the higher humidity period to such an extent that the original expansion gap has been lost completely, due to the climatic changes.
